Wind Turbine Repairs

January 6—June 9, 2017

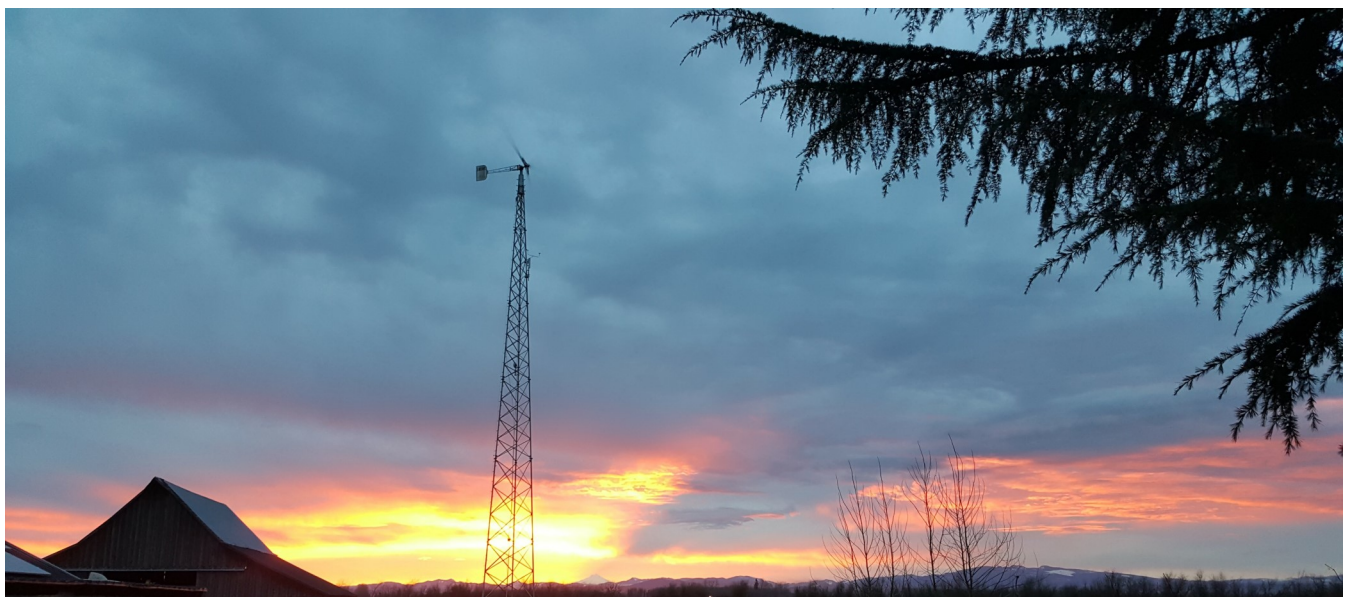
As the cold finally gave way to more normal winter conditions, we began to hear grinding from the wind turbine — and the grinding got louder and louder. We tried to shut down the system but the braking system did not work. By late January the blades were spinning out of control at the slightest wind.

March, 2017. Wind spinning endlessly. Brake to system has also broken.

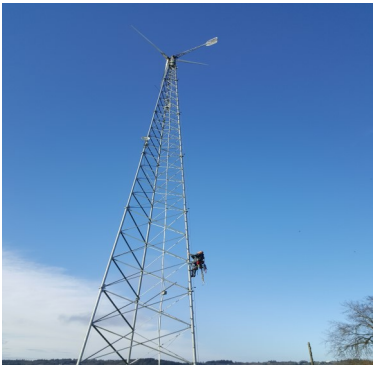
March 16 — Gilbert from Powder River dashes up the wind turbine and ties down the blade to prevent them from spinning.

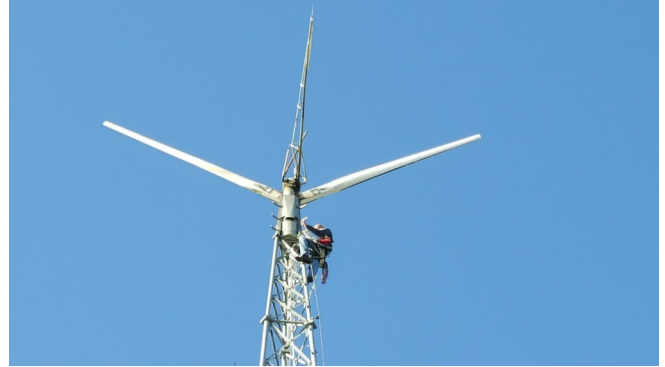
On March 27th, Powder River brought out a crane. The ground was so soft the crane was sinking in the pasture if it approached the turbine. So the smaller crane went back to Stayton and a larger 90 ton crane with 160' boom showed up later in the day. Gilbert climbed the ladder on the turbine, detached the casting tower and, using the crane, brought it down for evaluation and repair. All this occurred during typical winds and rains common to Western Oregon this time of year. Ken used our backhoe to remove the casting tower from the crane. The blades were removed and laid on the ground; the balance was secured upright, tied down and tarped to prevent damage from ongoing wind and rains. When time allowed on Casey's schedule, the gear head was detached and brought into our shop for diagnosis and repair. Casey disassembled portions of the gear head. Upon examination, Casey and Ken felt that the pinion shaft had disintegrated over the past five years. It appeared the metal had not been "hardened," which would have been necessary to handle incessant friction and heat generated by the spinning of the shaft inside the pinion gear. By not being hardened, the pinion shaft malfunctioned from the time the equipment was first installed. The brake had also failed. We set about to order parts from Joe Straley, 320-267-9463, at Jacobs Wind Energy Systems which is located in Minnesota www.jacobswind.net It took several weeks for the parts to arrive. Parts ordered included: pinion shaft, pinion gear and hypoid gear.

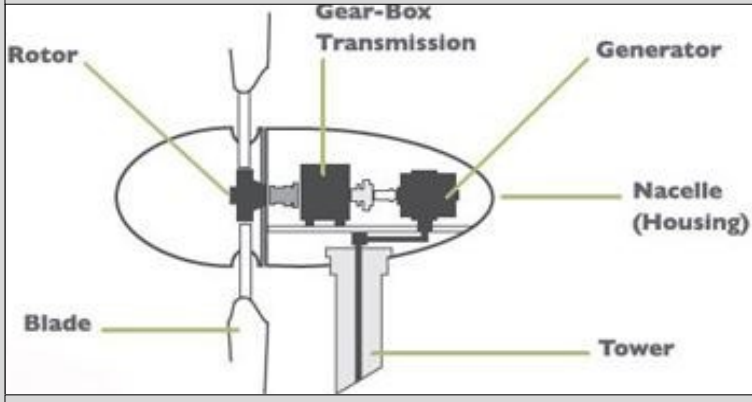
Repairs at Santiam Valley Ranch were concentrated in the Gear-Box Transmission and the mechanical floating caliper brake which is located between the gear-box and generator.

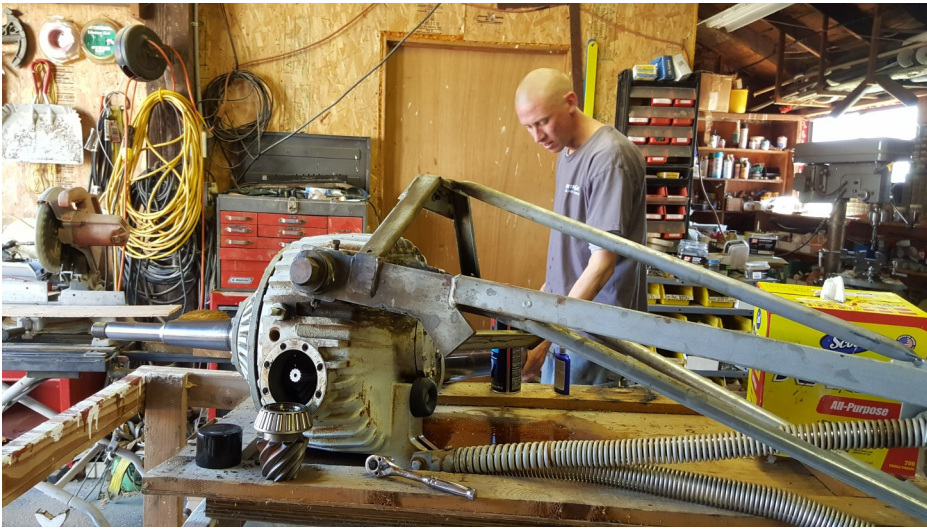
Casey working in the farm shop to replace the pinion shaft, pinion gear, hypoid gear and brake.

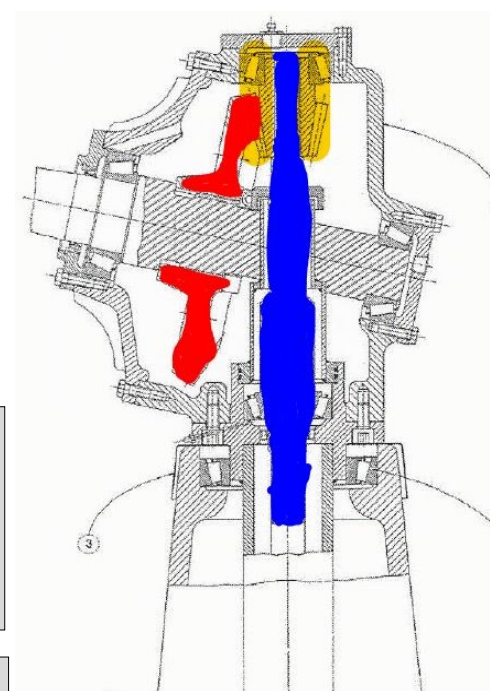
Right: Notes for diagram
 Parts replaced in Gear Head Transmission —
 Red: hypoid gear
 Blue: pinion shaft
 Yellow: pinion gear

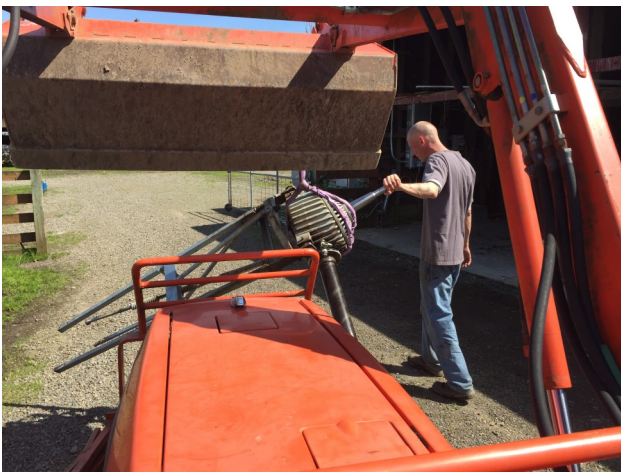
Left: Ken and Casey reassembled the gear box and used the tractor to transport it to the casting tower which is stored outside under a tarp.

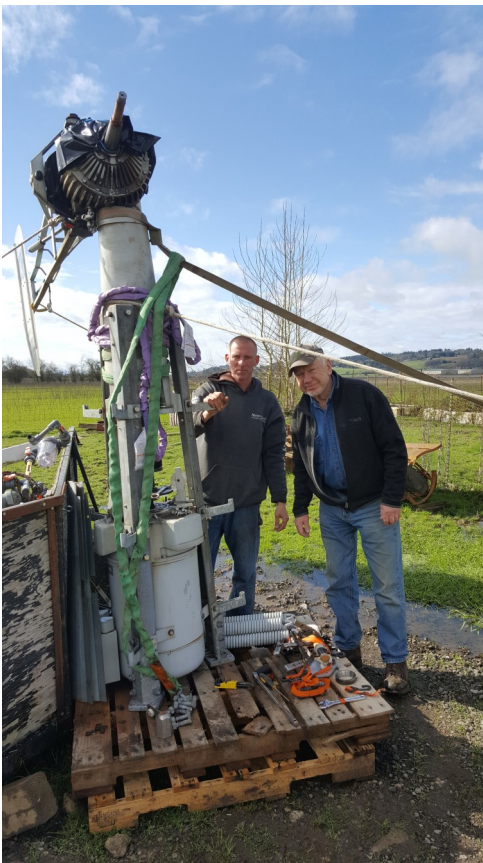
Ken and Casey reattached gear box to casting tower and attached the blades.

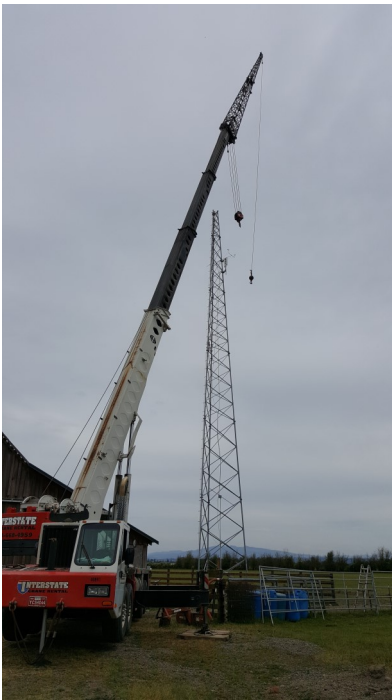
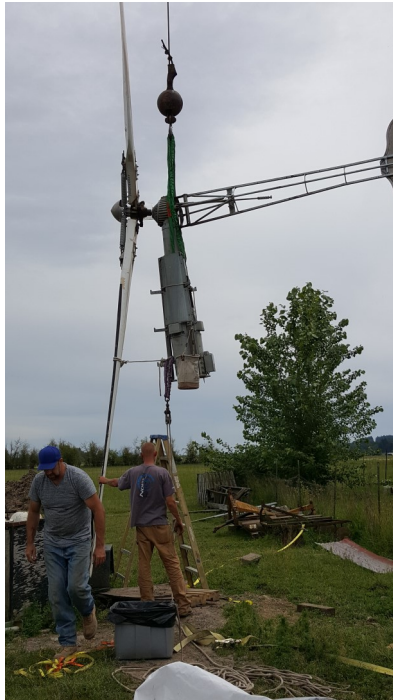
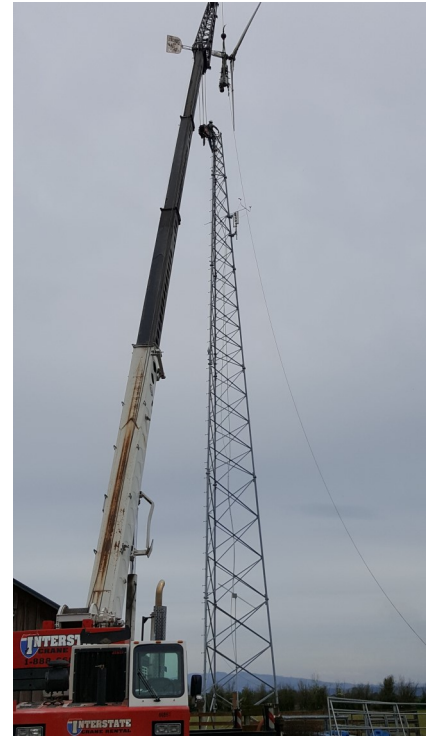
On June 7, Powder River brought a 90 ton crane with 160' boom and three professionals to the farm and remounted the casting tower to the top of the turbine. Gilbert is back on top, making it all happen!

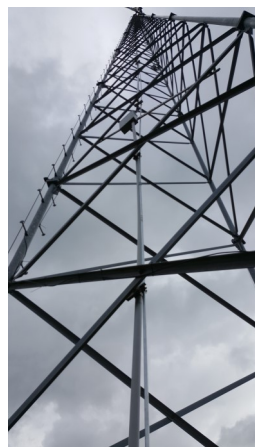
When the turbine was installed in 2010, the electrician did a very mediocre job. Although it was approved by Marion County, we felt that the PVC housing the electrical line needed to be replaced. Casey and Gilbert mounted metal conduit runs and installed a new rain tight junction box to replace the PVC box that leaked. The existing wires were re-pulled, along with sensor wires for URL software program.

New metal conduit mounted, replacing PVC electrical lines.
