Wind Turbine Repairs

January 6—June 9, 2017

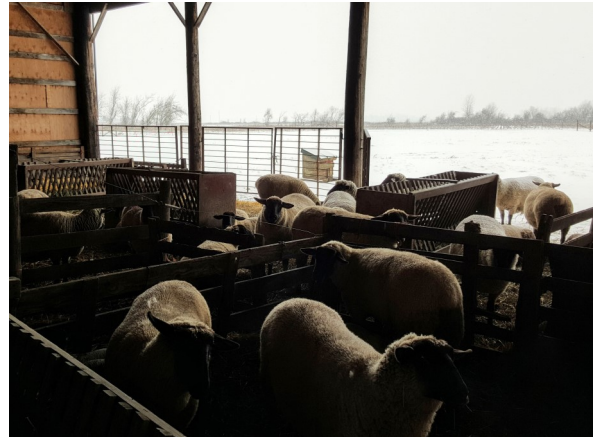
Lambing began on December 31, 2016. Here in mid-January, ewes are inside the barn to prevent birth of lambs outdoors in snow and freezing temperatures.

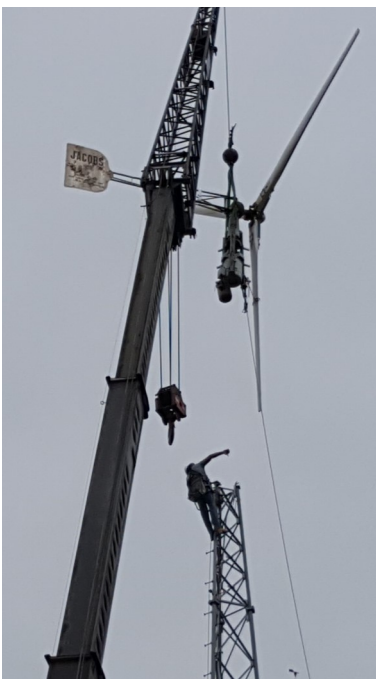
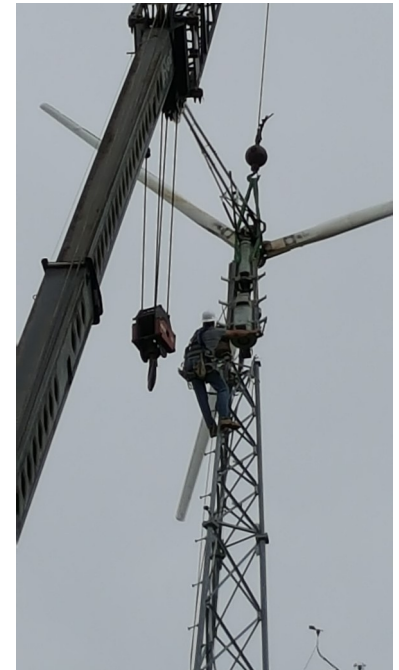
When the turbine was installed in 2010, the electrician did a very mediocre job. Although it was approved by Marion County, we felt that the PVC housing the electrical line needed to be replaced. Casey and Gilbert mounted metal conduit runs and installed a new rain tight junction box to replace the PVC box that leaked. The existing wires were re-pulled, along with sensor wires for URL software program.

And then we pulled the "On" lever!
